HAWKINSVILLE DAM FINAL STUDY

HAWKINSVILLE DAM PROJECT

Hudson River-Black River Regulating District Albany, New York

August 2014

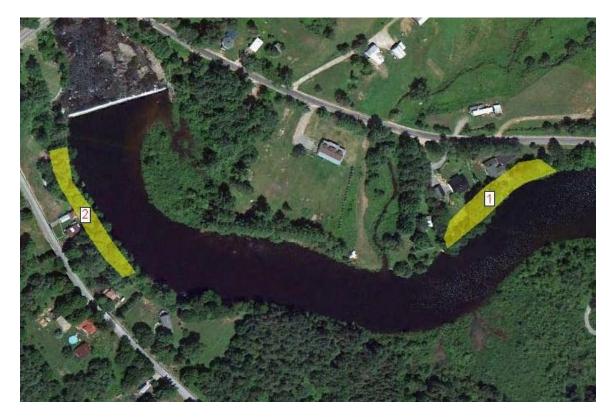
FIGURE 3-2. AREAS OF CONCERN FOR BANK INSTABILITY AFTER THE HAWKINSVILLE DAM IS REMOVED

At Area of Concern (AOC) 1 (Figure 3-2), the Black River takes a sharp turn to the west. The slope on the east bank is steep (nearly 1:1), and mature trees anchor the riverbank. If the dam is removed, the water levels will be approximately 4 feet lower, and the water velocities will increase 1 foot per second during a channel-forming flow (i.e., the 2-year reoccurrence interval). Although these changes are small, the new hydraulics could erode the slope, potentially increasing the chance for bank instability. At AOC 2 (Figure 3-2), the river takes a mild bend to the west. The bank slope and anchoring are similar to those at AOC 1. At AOC 2, the water levels will be approximately 5 to 6 feet lower and the water velocities will increase 4.5 feet per second during a channel-forming flow. These changes are more significant and pose a greater risk for bank instability. To help mitigate the risk, the left abutment of the dam will remain in place to deflect erosive flows away from the bank. In both cases, the bank should be monitored after the dam is removed. Potential engineering solutions to improve bank stability include biostabilization or rip-rap of the bank slope, if necessary.

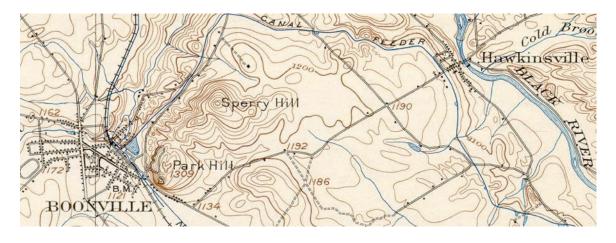
Figure 2. Portion of 1874 Oneida County Atlas, showing Hawkinsville

In the mid-nineteenth century, Hawkinsville and its manufacturing plants grew largely because of the combined water power and transportation provided by the Black River. The 1874 Oneida County Atlas (Figure 2) shows the village at its heyday, when buildings lined both side of the principal street in the village on the west side of the Black River, between the Black River and the Black River Canal. The principal business in the village by this time was a tannery, which was located slightly downstream of the village on the east side of the Black River. A tributary to the Black River featured a dam with a small mill pond that provided power to the tannery. There is evidence also that a mill was located at the site of the present dam in the 1880s, though no maps showing this mill were found during the current research.

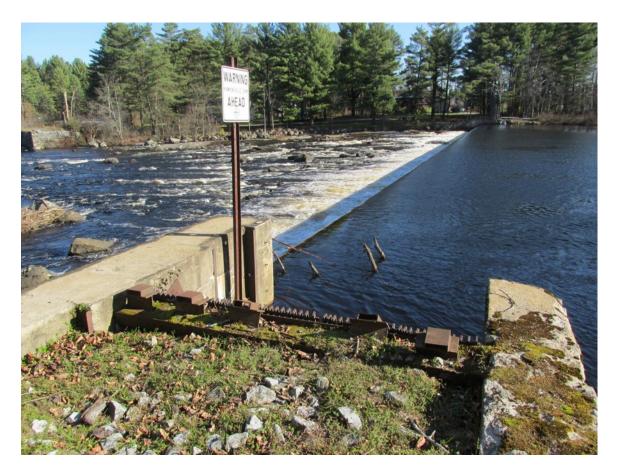
Figure 6. Crest of dam looking E, 2013.

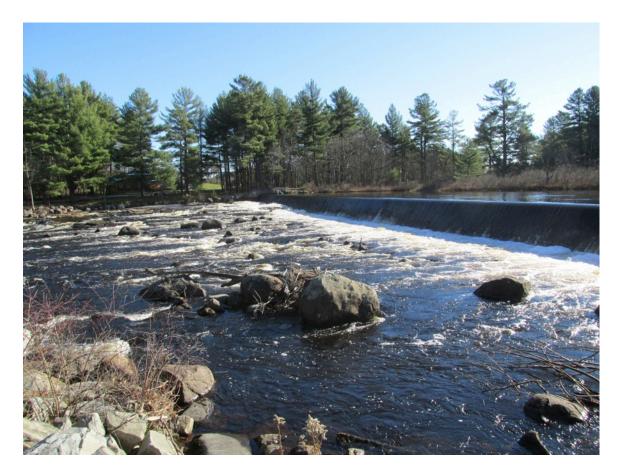
Figure 7. Dam and intake looking NE, 2013.

The dam was designed and permitted for the generation of power, with a concrete intake on the left (west) side of the dam. The intake fed water to a penstock that originally measured 5'-10" in diameter. The Brant Excelsior Company factory was located on the west side of the Black River, immediately downstream of the dam on the south side of Rt. 61. An undated postcard shows the factory as a one and one-half story frame building with a gabled roof, above a raised basement where the ground slopes down to the river (Figure 4). An auxiliary building extended to the north from the main factory building. This building was built in 1929, when the original mill was destroyed by fire. A slightly larger penstock, measuring six feet in diameter, replaced the original penstock in 1959 (Ryder 1966). The factory was closed in 1966. No evidence was found during the present research to indicate that the dam has been replaced or significantly altered.

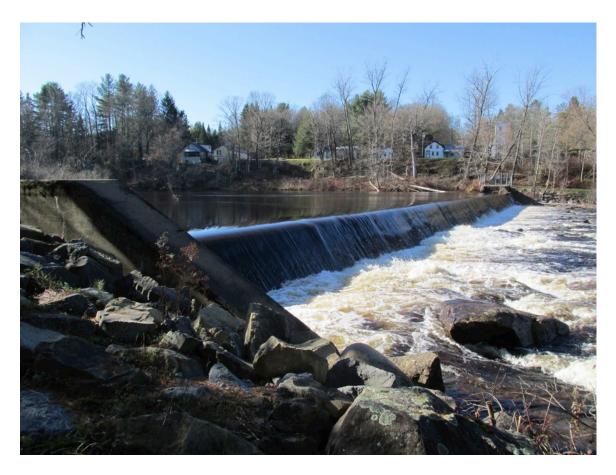
Figure 8. Downstream face of dam looking SE, 2013.

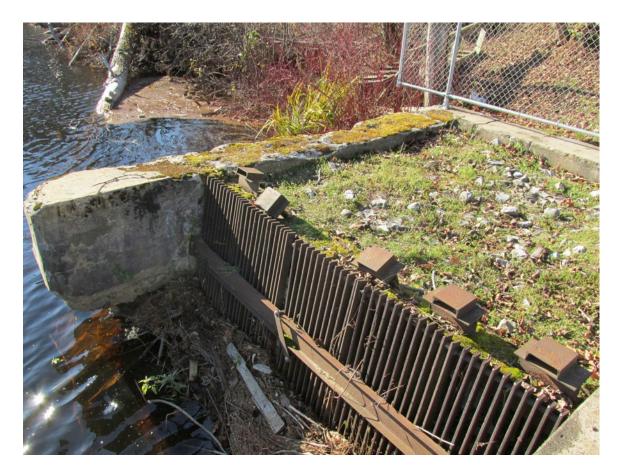
Figure 9. Downstream face of dam looking SW, 2013.

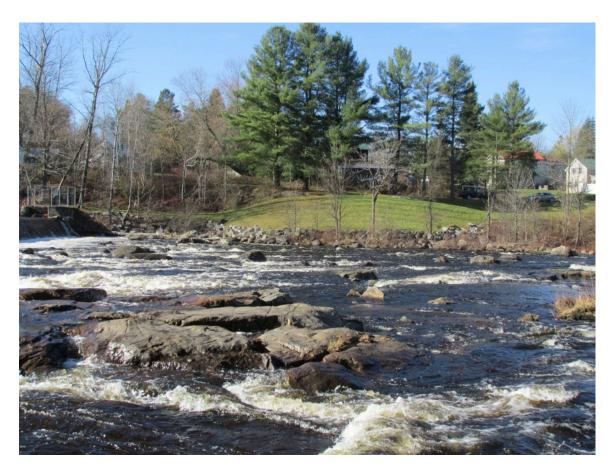
Figure 11. Downstream face of intake, showing penstock outlet.

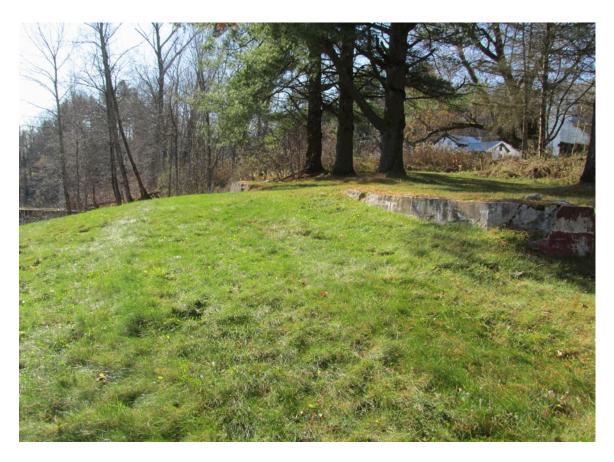
Figure 12. Former factory site looking SW, 2013.

As noted above, the Brant Excelsior factory closed in 1966, and all of the equipment and machinery were removed at that time. The building remained standing for many years, but is now gone and the land where it stood has been re-graded. Only a small portion of the concrete foundation remains to indicate the location of the factory. Figures 12 and 13 present views of the former factory site.
